ENGINE DISTRIBUTORS SERVICE BULLETIN

GX35NT • GX35T (GY5) FUEL STARVATION

OVERHEAD-VALVE ENGINE #52 JANUARY 2015

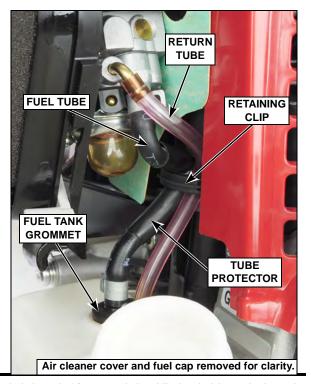
The fuel starvation is due to a kink in the fuel supply tube between the fuel tank and the carburetor. The fuel tube is too long, resulting in excessive bending and kinking of the tube where it passes through the fuel tube retaining clip.

To reduce the excessive bending at the retaining clip, replace the fuel tube and fuel tube protector following the procedure beginning on page 2.

A new tube protector must be installed. The original tube protector can retain the shape of the original fuel tube and cause the new fuel tube to kink.
