Service Bulletin

Product: 2014 Dual Stage Snow Throwers

Husqvarna has received reports of premature belt wear on dual stage snow throwers. While all dual stage models made in 2014 are included in this bulletin, not all units may experience premature belt wear. This bulletin involves the following:

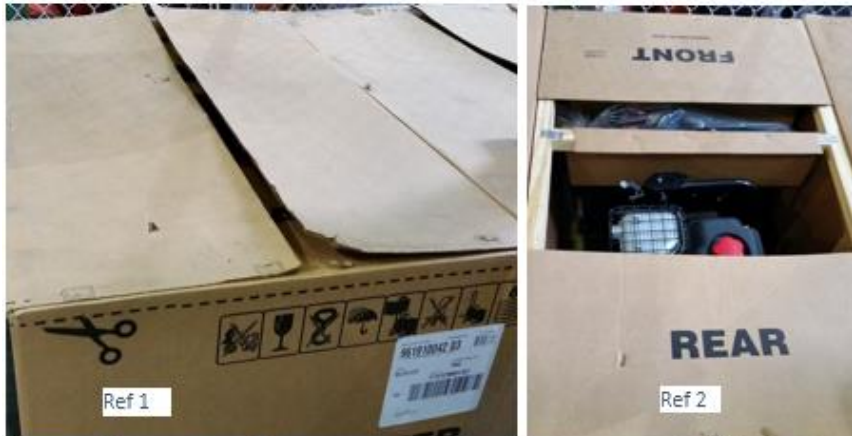
Opening Carton:

Open the top flaps to access the snow thrower (Ref 1). Unit can be accessed after folding back the two top flaps, and the "front" marked flap (Ref 2, 3). Pulley cover will need to be removed to access pulleys. Remove the two screws holding the pulley cover as indicated by green arrows (ref 4, 5). Pulley cover can be lifted off for access to pulleys to complete rework (ref 6)

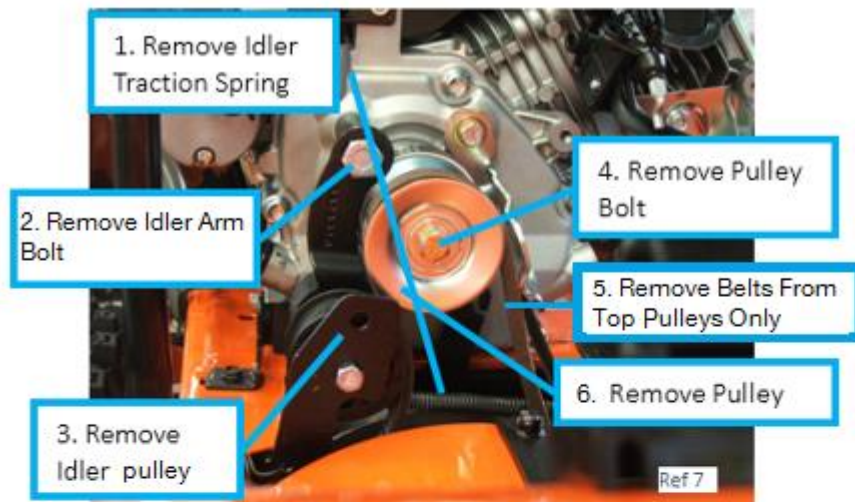
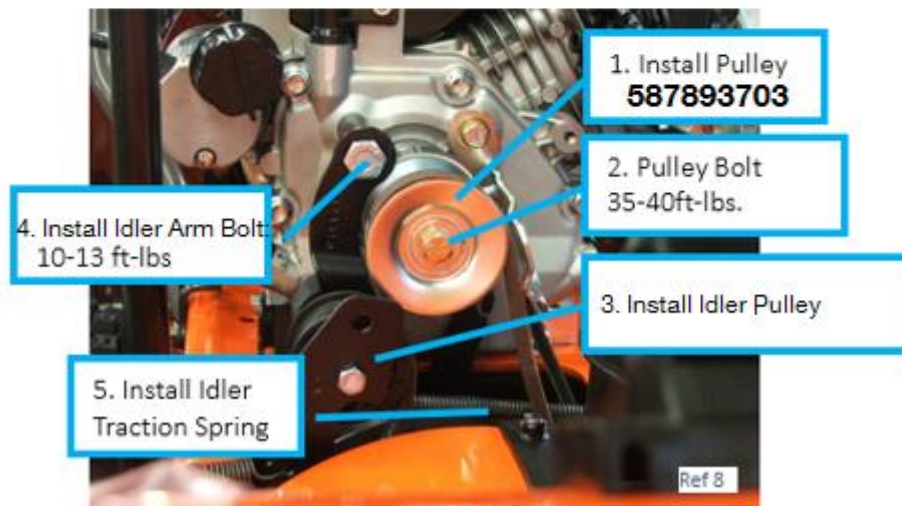
1. Replace Engine Pulley

Remove old pulley and replace with new pulley (Reference Part Number for new engine pulley: **587893703**). Belts must be removed and reinstalled onto new pulley. Be careful not to roll the belts nor damage them when removing or installing them over pulley flanges.

10-13 ft-lbs is 14-18 N-m

35-40 ft-lbs is 47-54 N-m

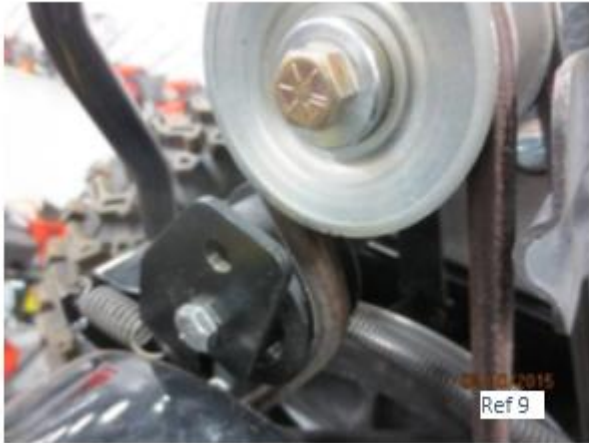
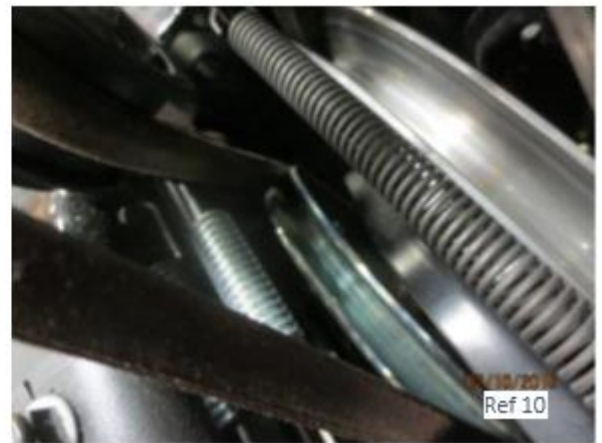
2. Check belt routing

Check that (2) belts are routed around upper and lower pulleys at drive and idler pulleys. See Ref 9 and Ref 10.

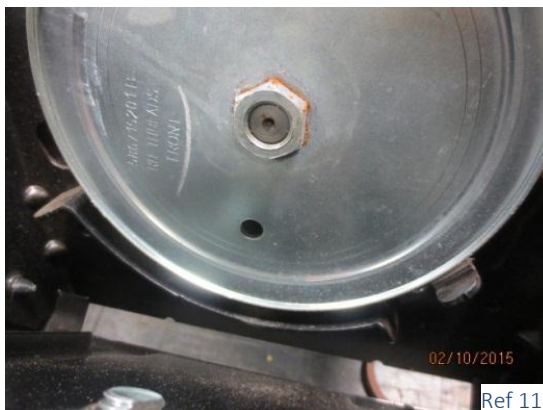
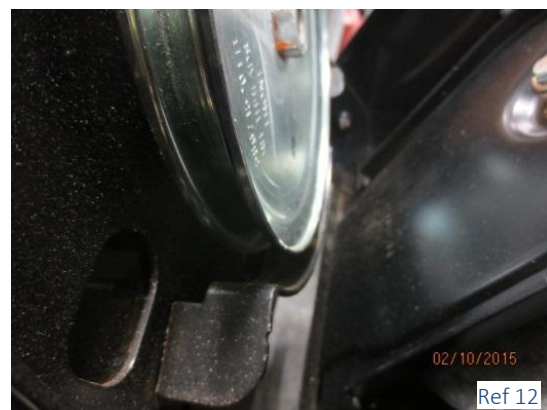
Bottom belt keeper

Check the impeller belt is seated in pulley groove between pulley and keeper (Ref 11, 12). The top belt keeper should not touch the belt when auger lever is engaged, and provide clearance of 0.0" to 0.090" (0mm to 2.3mm). If needed, bend the top belt keeper to allow for proper clearance (Ref 13, page 6).

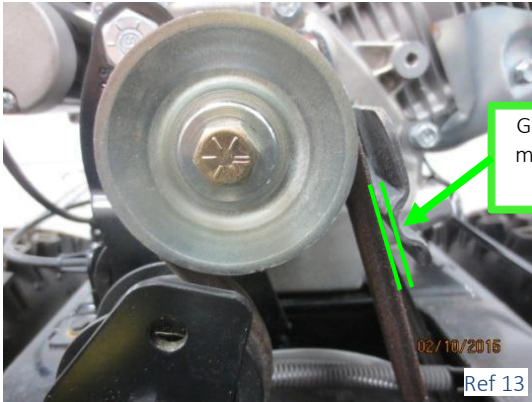
02/10/2015
Ref 13

Top Belt Keeper

Gap 0.0" to 0.090" (0 mm to 2.3mm) Auger lever engaged

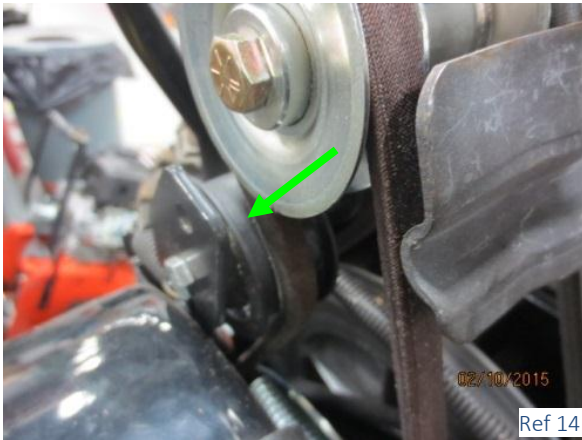
02/10/2015
Ref 14

Verify that the belt is riding near center of idler pulley and does not contact outer flanges of pulley (Ref. 14).

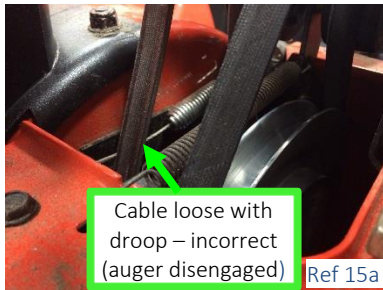
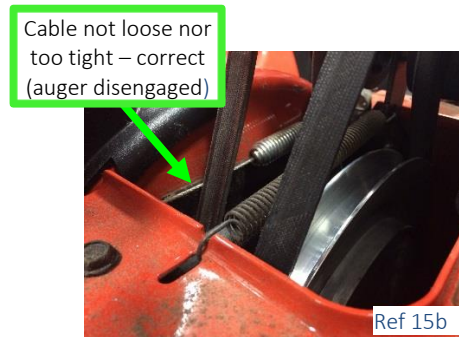
Auger cable spring

To check belt tension, verify there is no slack in the cable with auger control disengaged. The cable must have all free travel removed but not stretch the spring. (Ref. 15a and 15b)

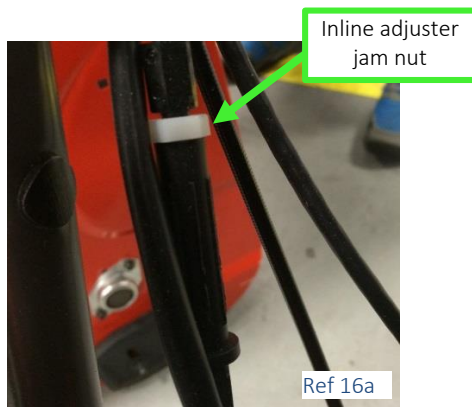
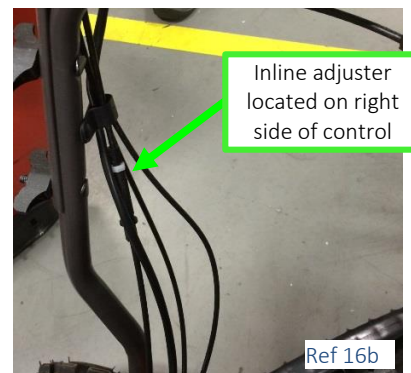
Auger cable adjustment

Adjust cable tension with inline adjuster located on the right side of operator control handle. Loosen white jam nut of cable inline adjuster. Hold one side of the adjuster while turning the other side. This lengthens or shortens the cable. Adjust until cable tension is correct (Figs. 16a and 16b). Tighten jam nut.

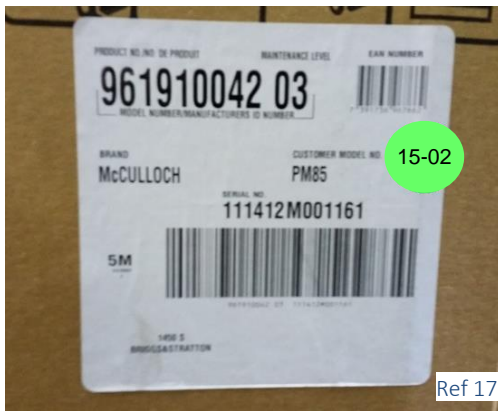
Replace cover that was removed for access (Ref 6). Install and tighten bolts to secure (Ref 4, 5). If unit is still in outer packaging, close and secure shipping carton. Mark the outer label of the shipping carton with project number "15-02". (Ref 17).
